—HIDOH / USGS Cooperative Program—

**Wastewater and Nutrient Source
Tracking – Results of
Reconnaissance Chemical Mapping
at Kualoa and Kahana, Oahu**

Chip Hunt, USGS

Pacific Islands Water Science Center

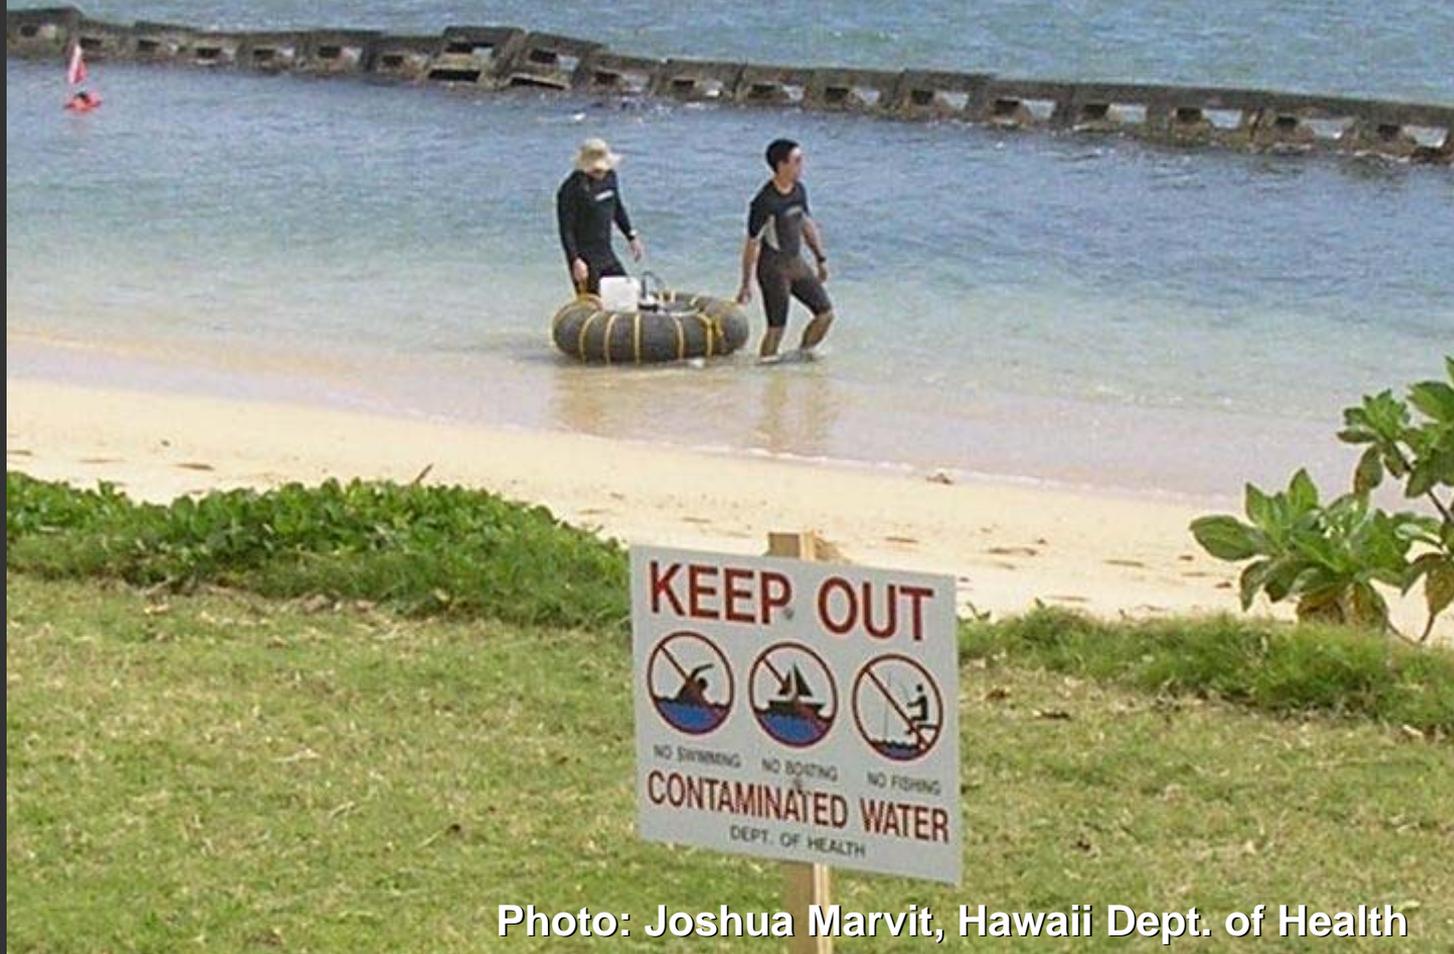
DOH Wading Platform

Multiparameter
water-quality
instrument

Keypad
and GPS

Wading survey just off the beach

- Wading instrument surveys (continuous)
 - GPS “trackline” fixes at 30-sec intervals
 - Multiparameter—Salinity, DO, chlorophyll, etc
 - Coming soon—fabric-brightener fluorescence
- Wading dip samples (fewer discrete points)
 - Fabric-brightener fluorescence, handheld meter
 - GPS “waypoint” fixes
- Beach porewater transects (discrete sites)
 - Lab analyses for various tracers

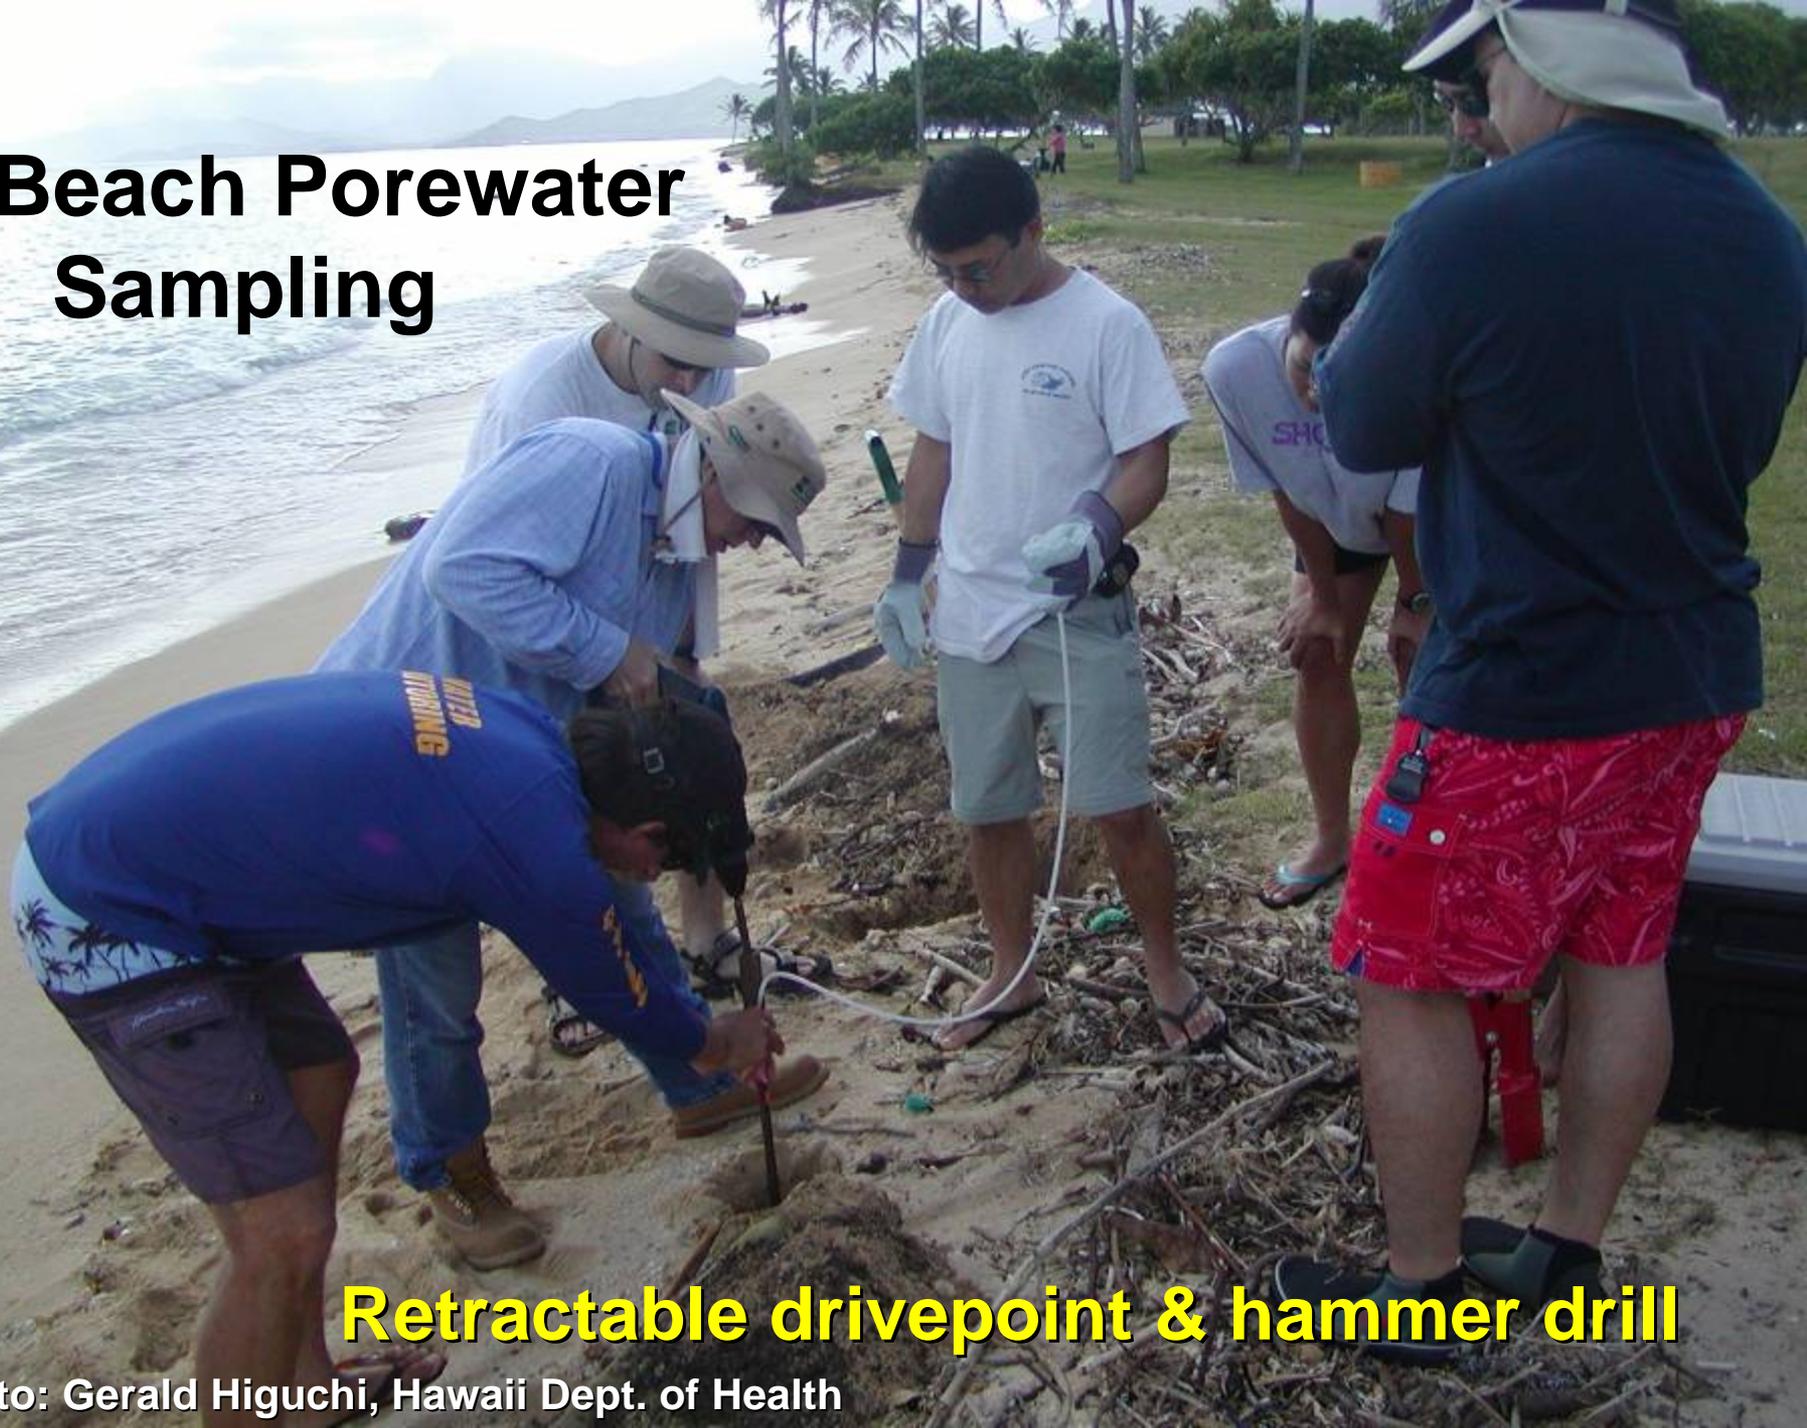
Beach Porewater Sampling

Retractable drivepoint & hammer drill
