MONITORING EROSION ON KAHO'OLAWA

A USGS study in cooperation with the Kaho'olawe Island Reserve Commission

By Scot Izuka, USGS

Presented at the Hawaii Water Quality
Conference March 25, 2008

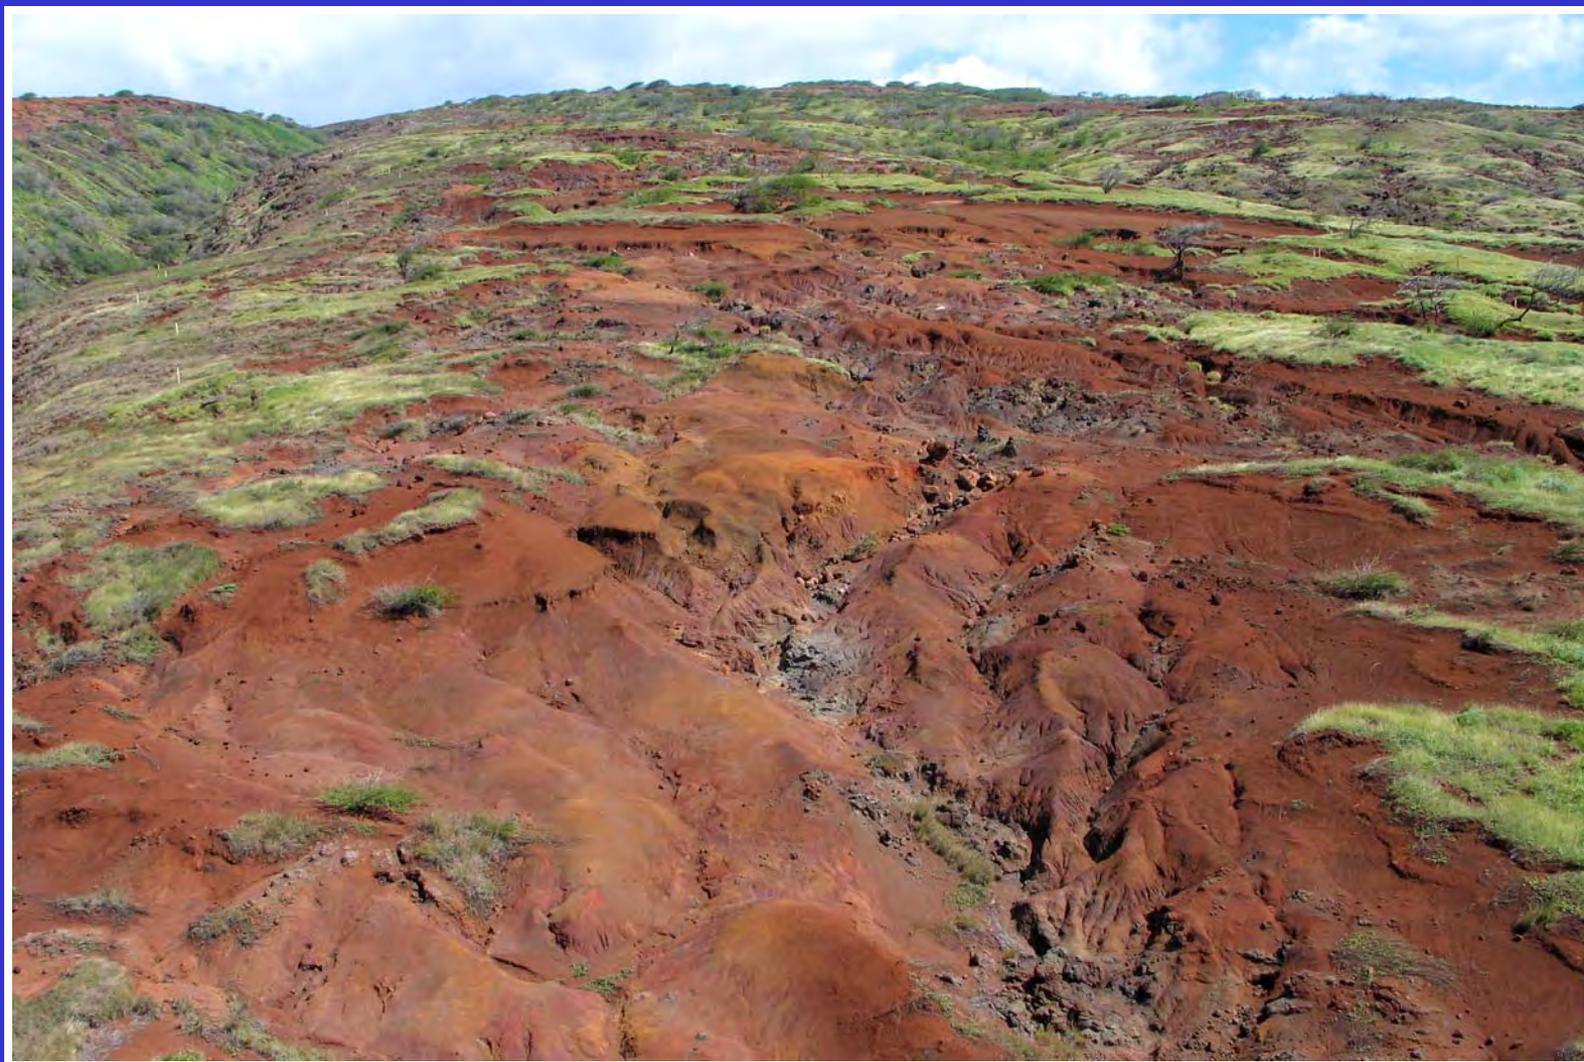
Badlands

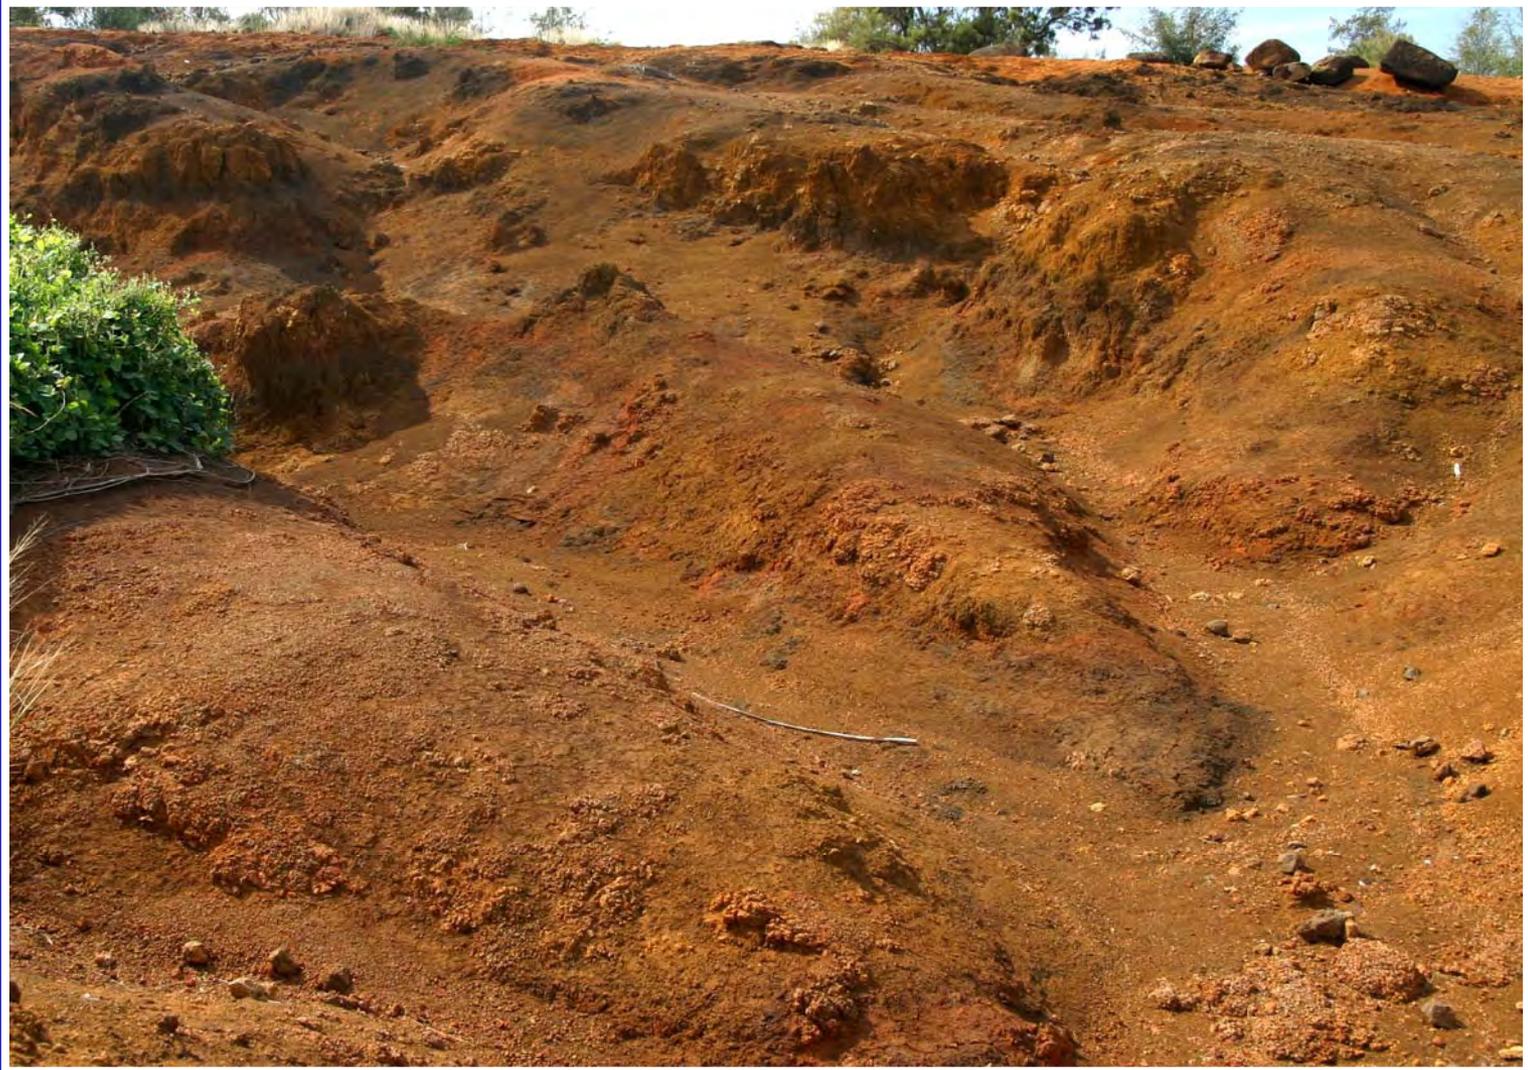
Badlands Erosion in Soft Material

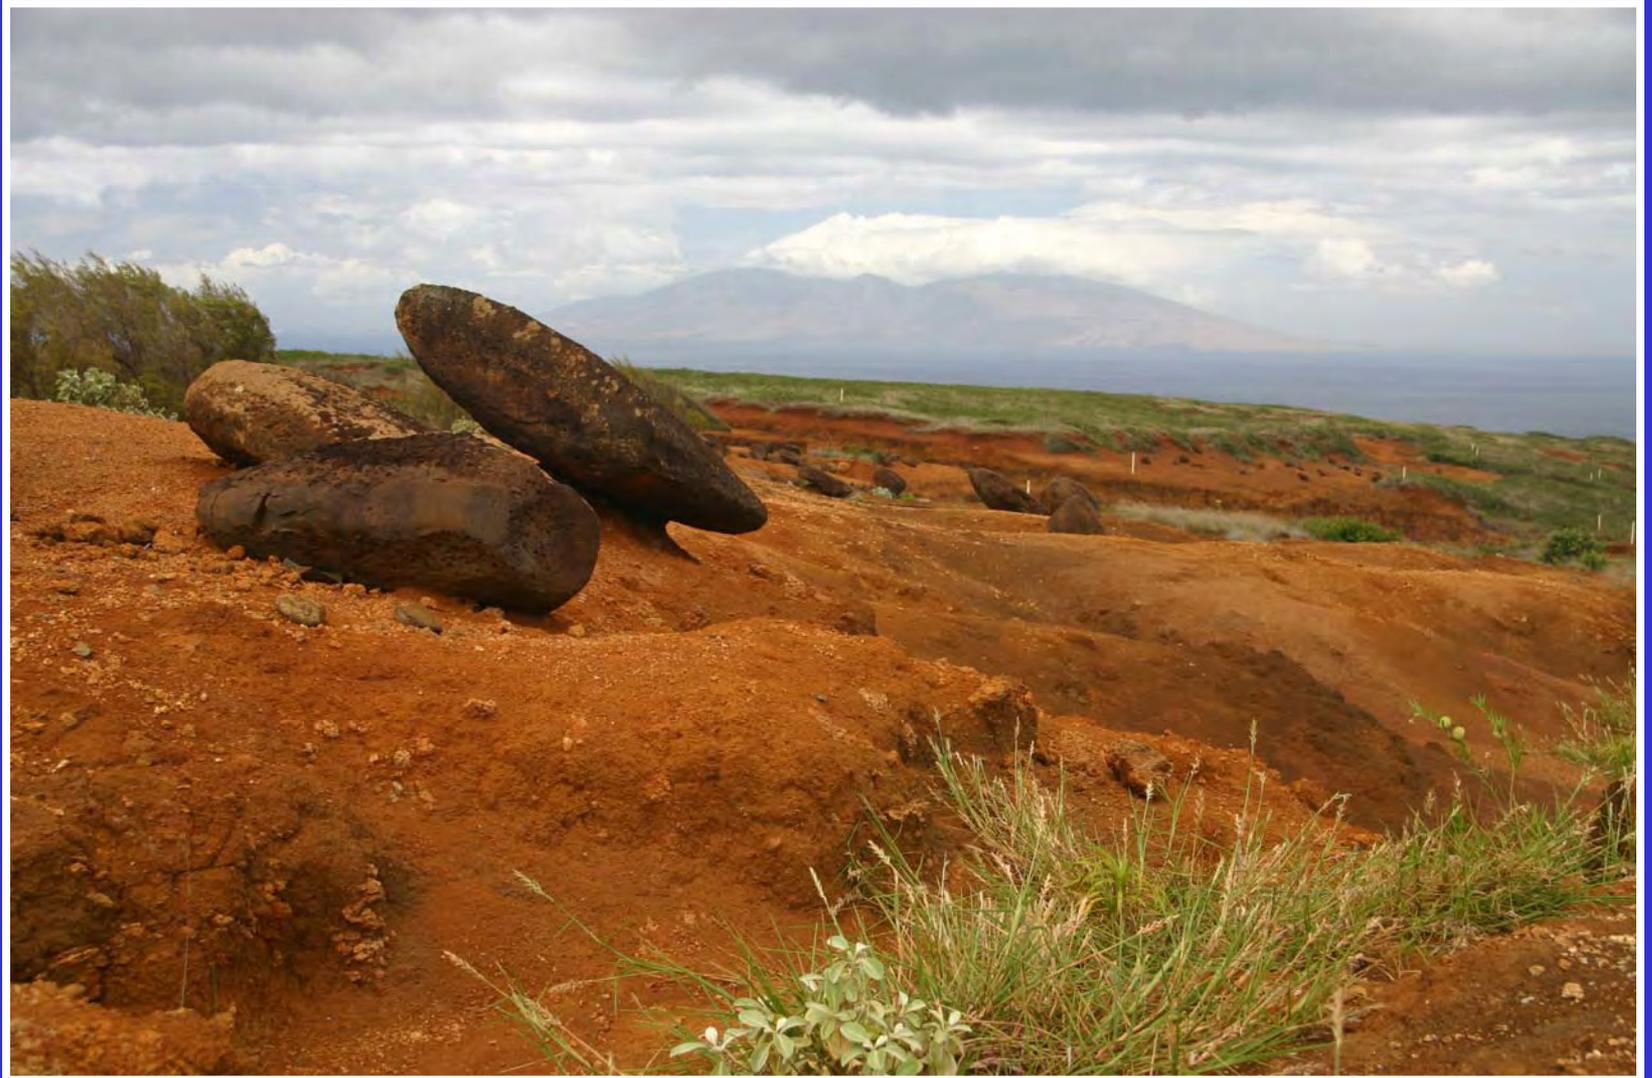
Pedestal Rocks

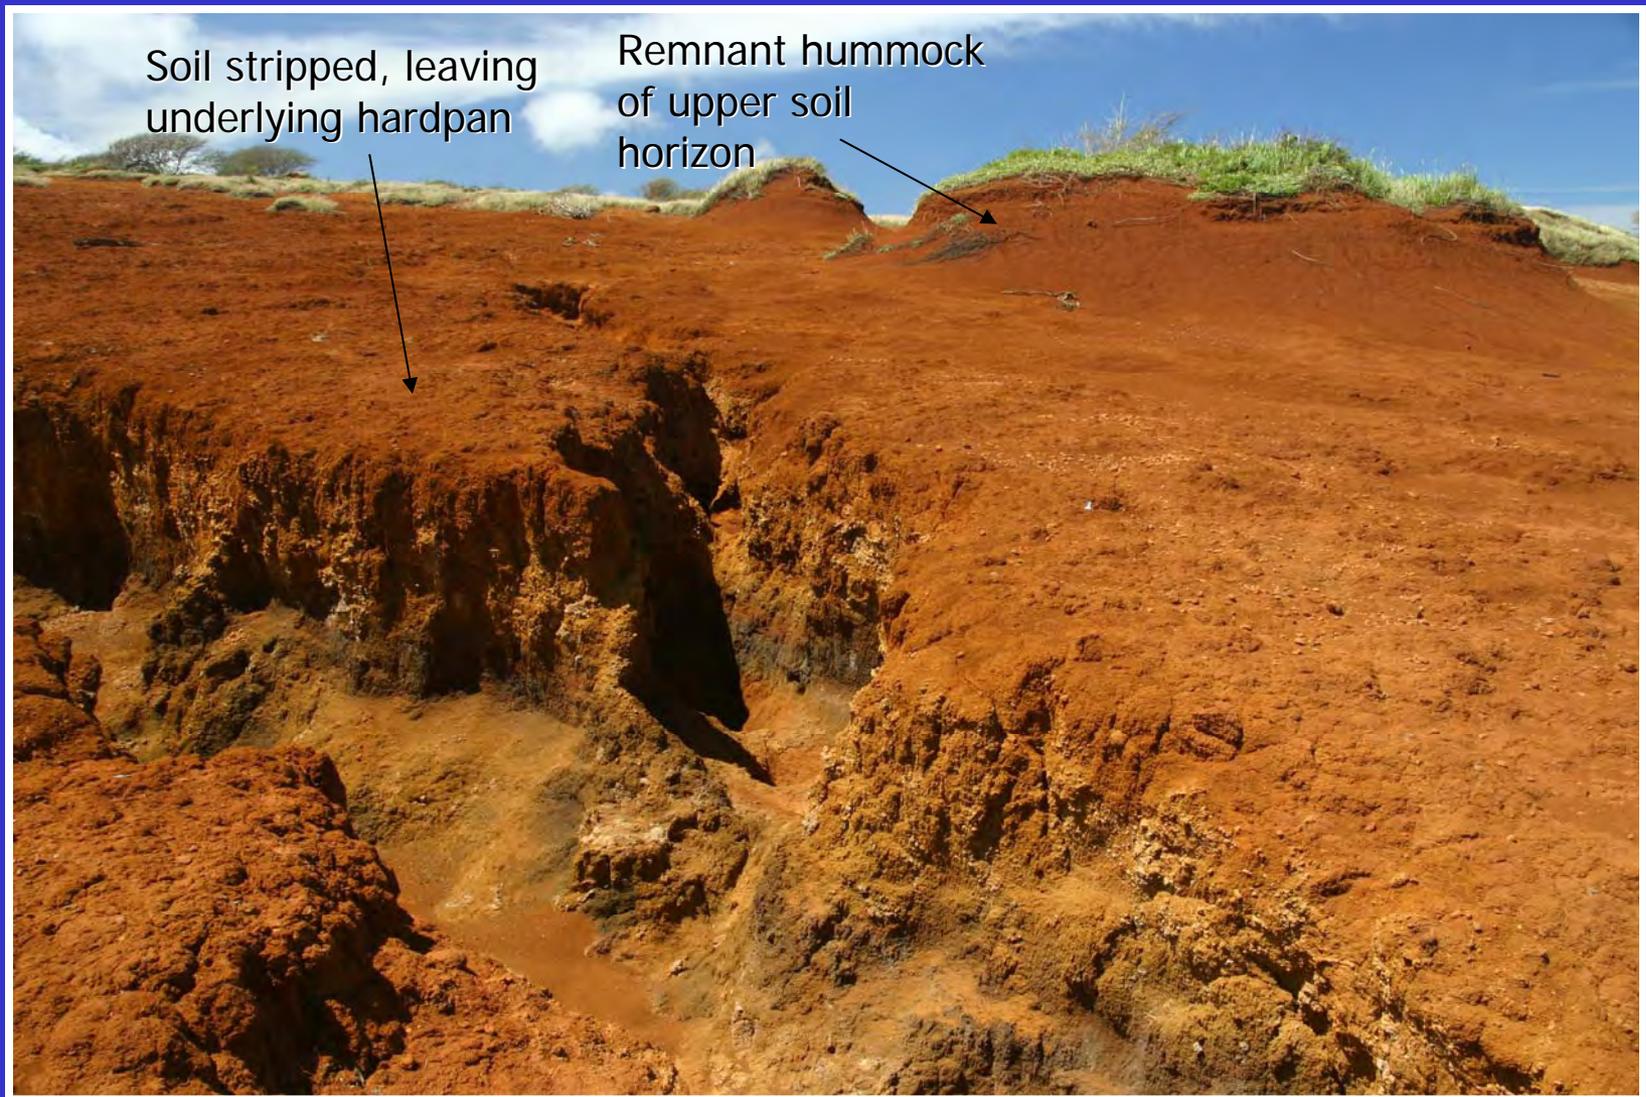
Upper Horizon is Removed in Many Areas

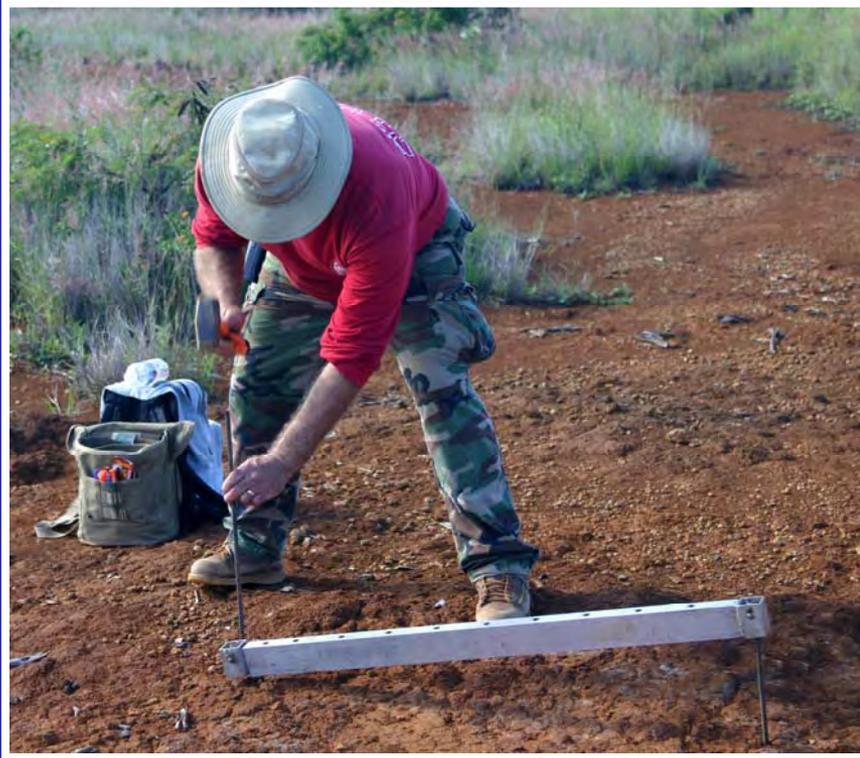
Erosion Monitoring Method

Install transects ("pins")

Measure ~ every 6 months
for 3 years

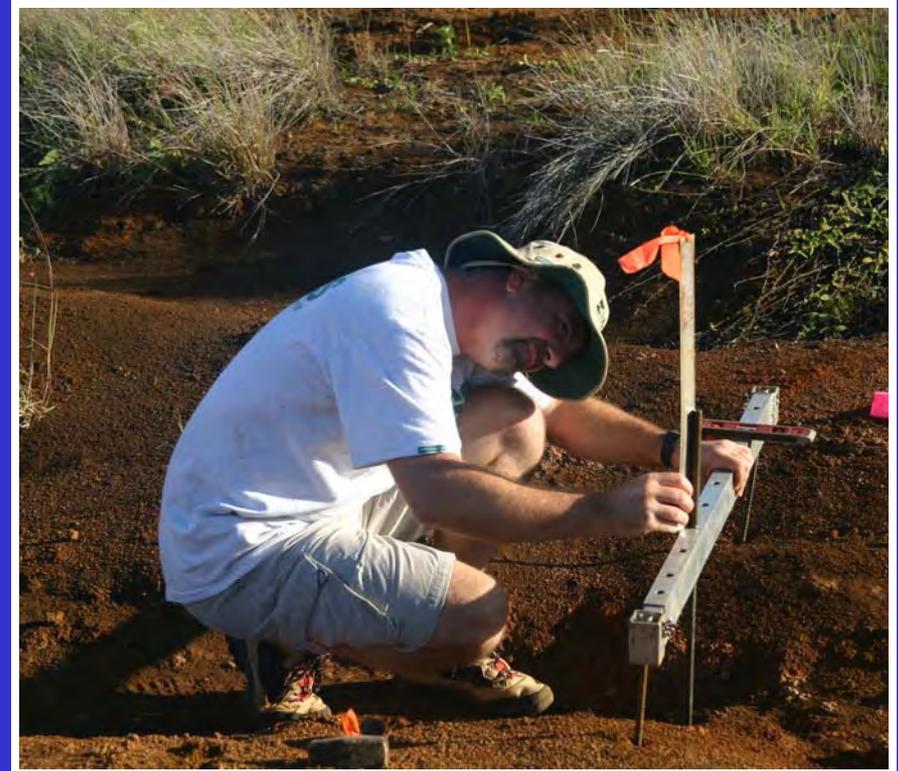
Transect Locations

Kaulana

Hakioawa

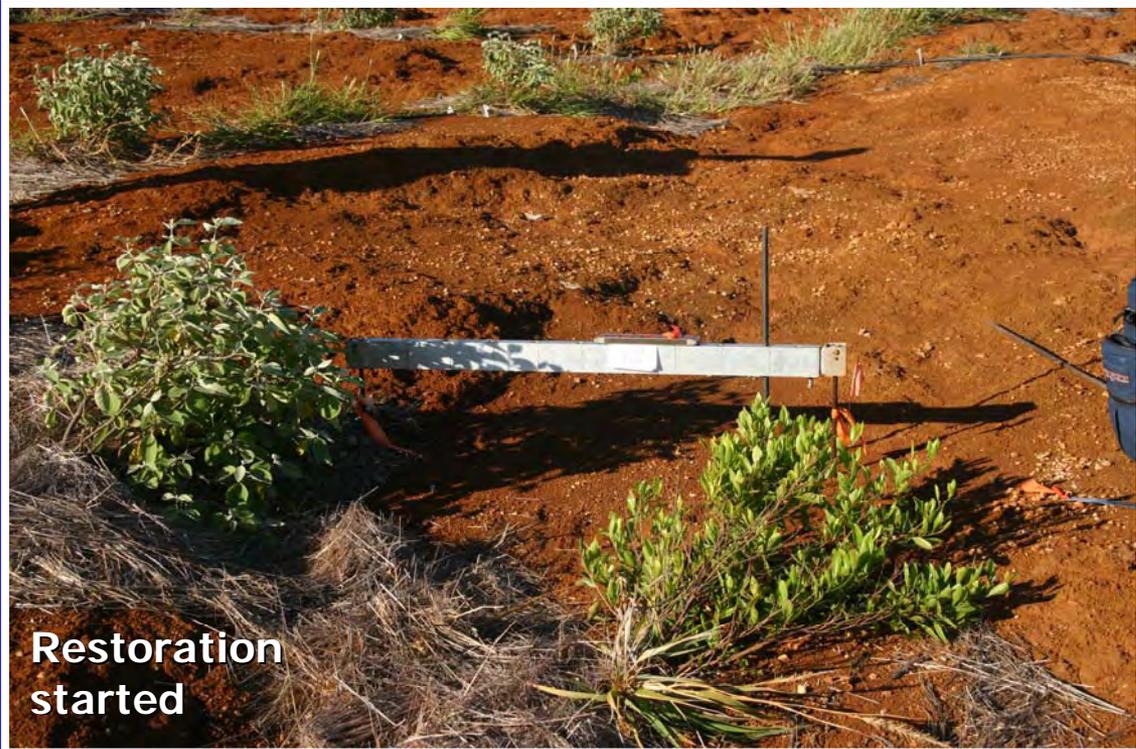
Restoration started

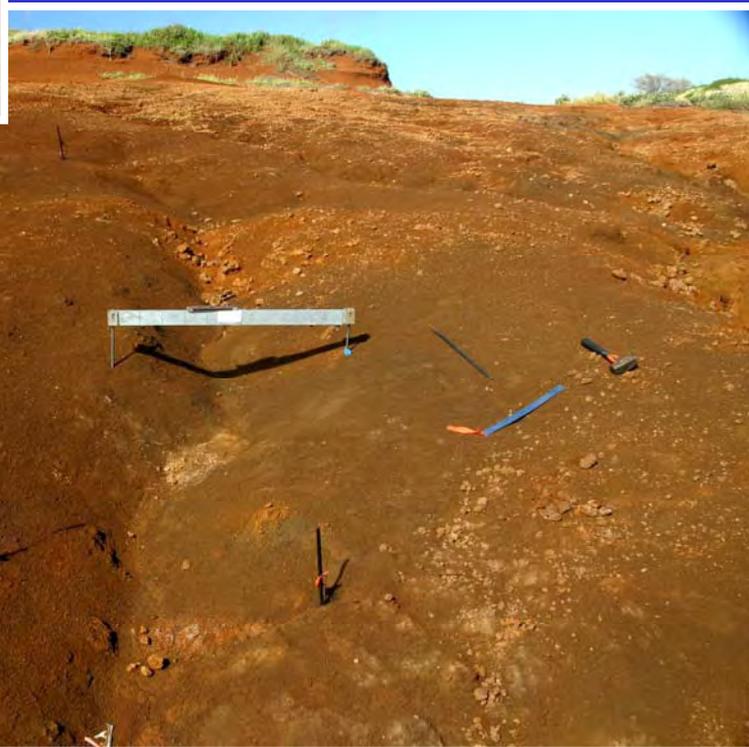
No restoration

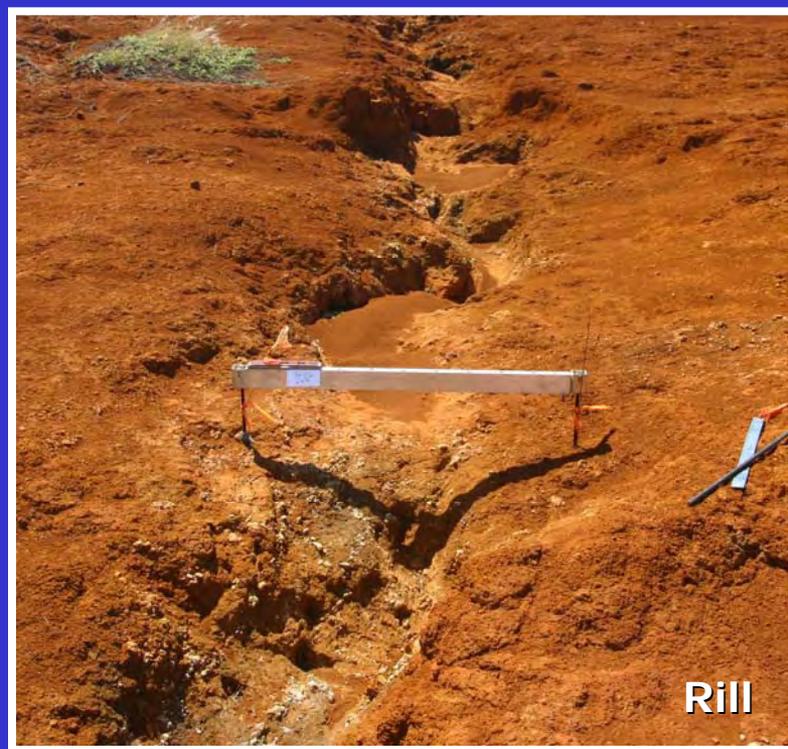
Rill

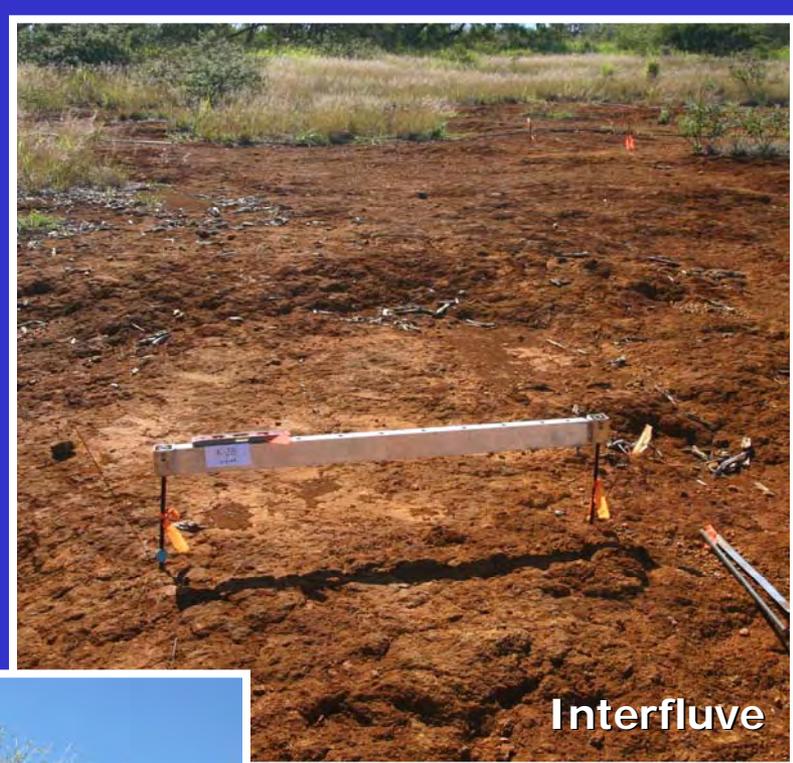
Interfluve

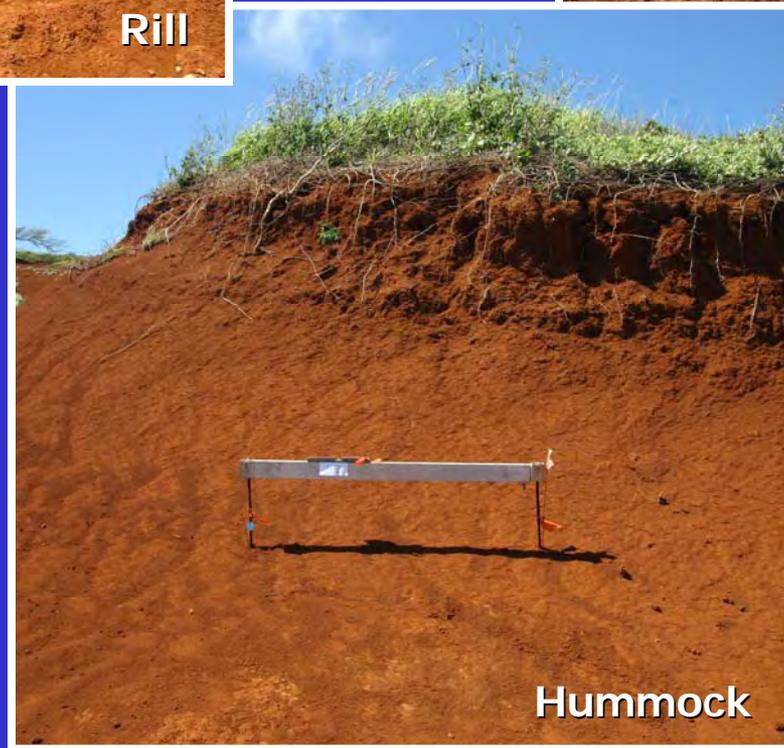
Hummock

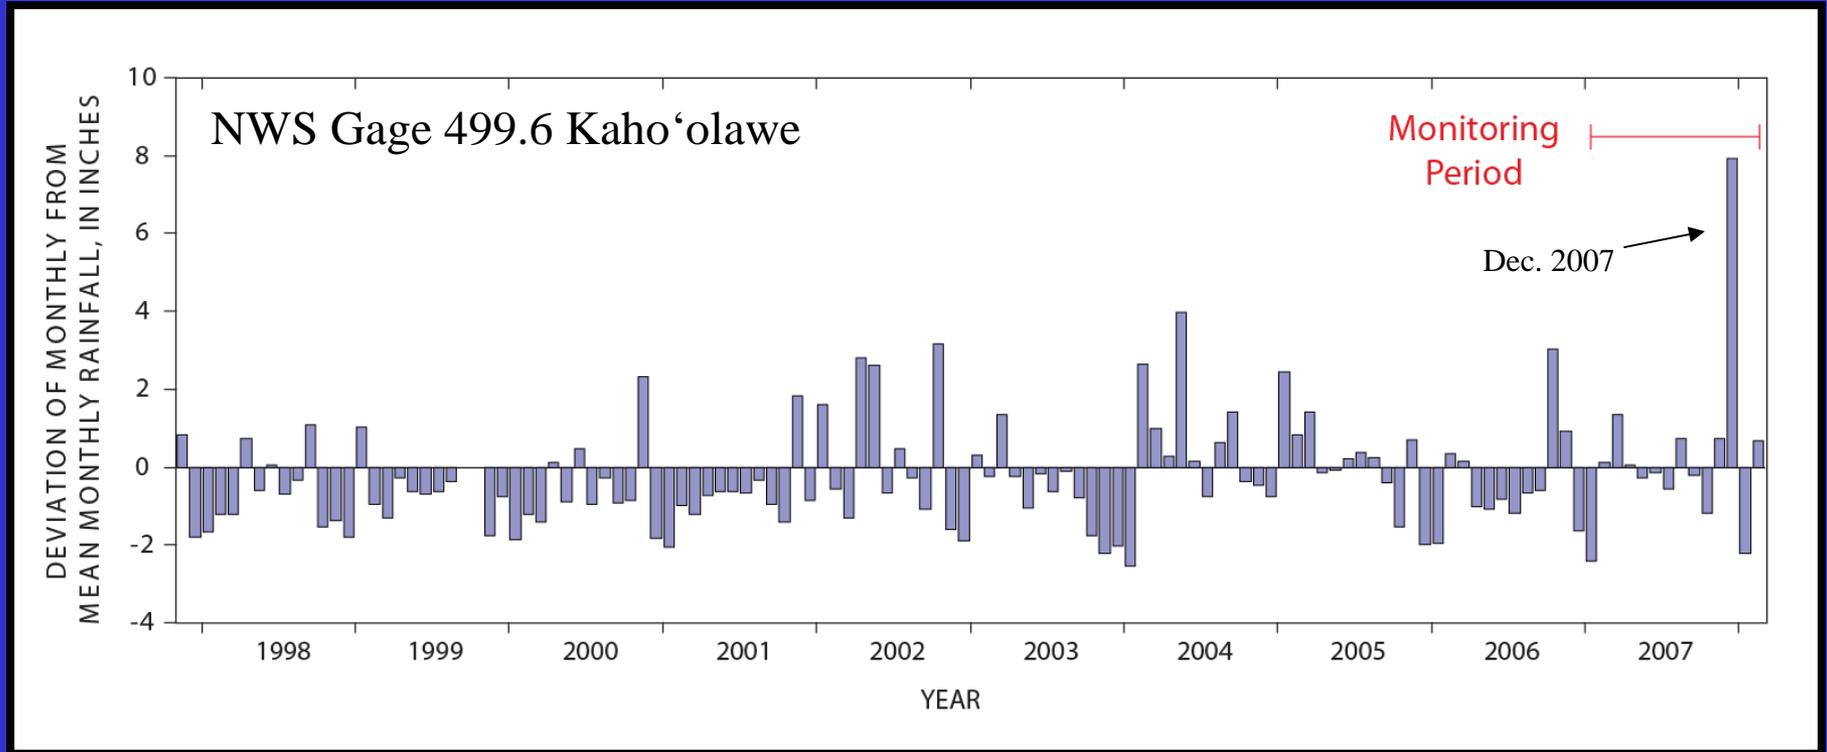
Rainfall During Erosion Monitoring

Data from National Climatic Data Center and National Weather Service (Data after November 2007 is preliminary and subject to change)

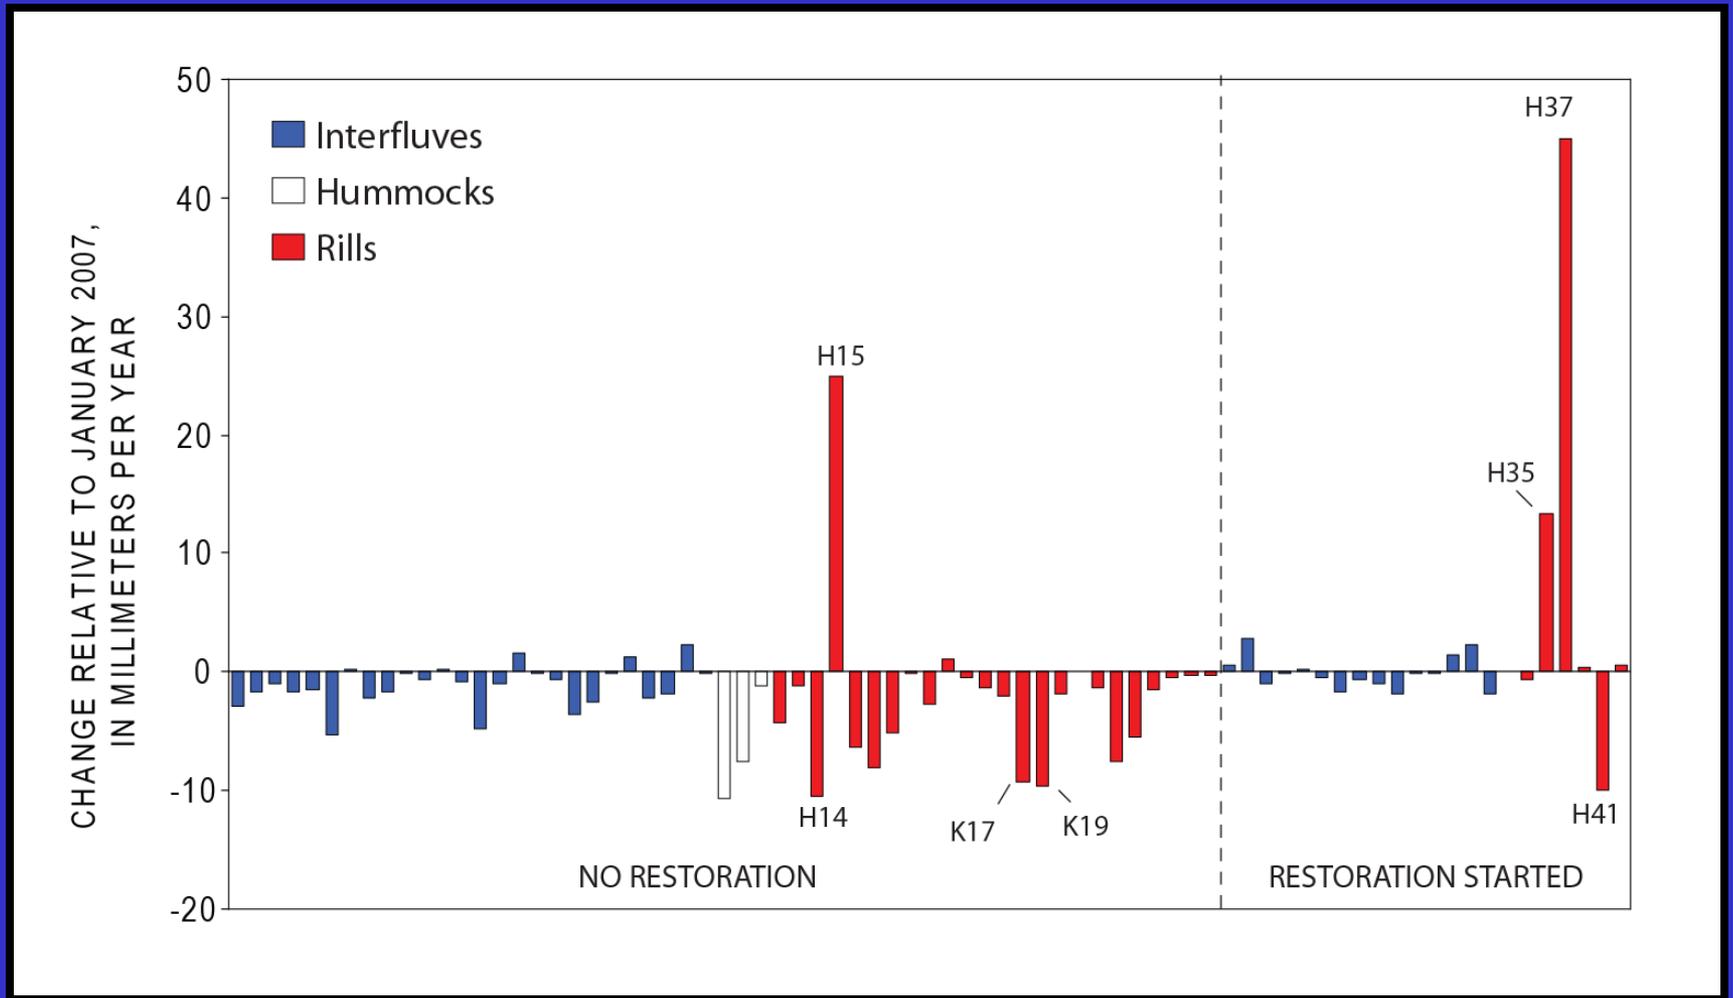
Even So, Rills Show Extremes of Erosion/Deposition

Rills show extreme variability in deposition and erosion

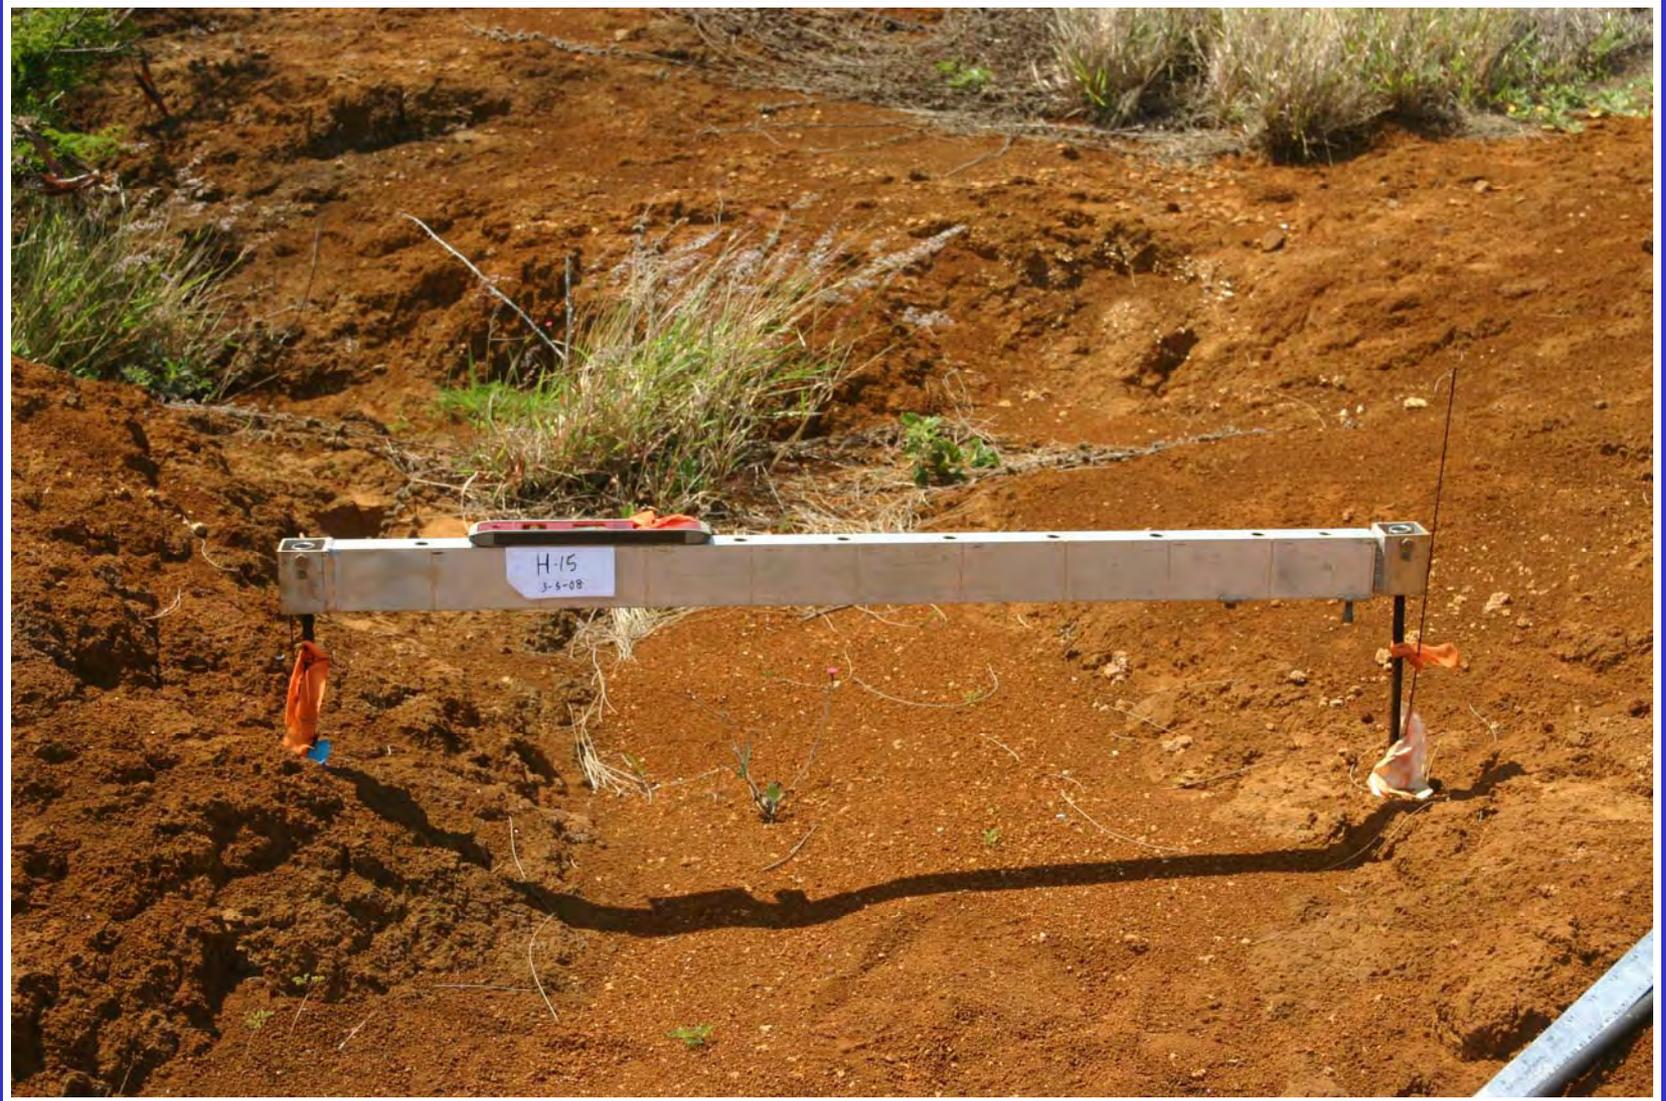
H15 – Sediment deposition in rill

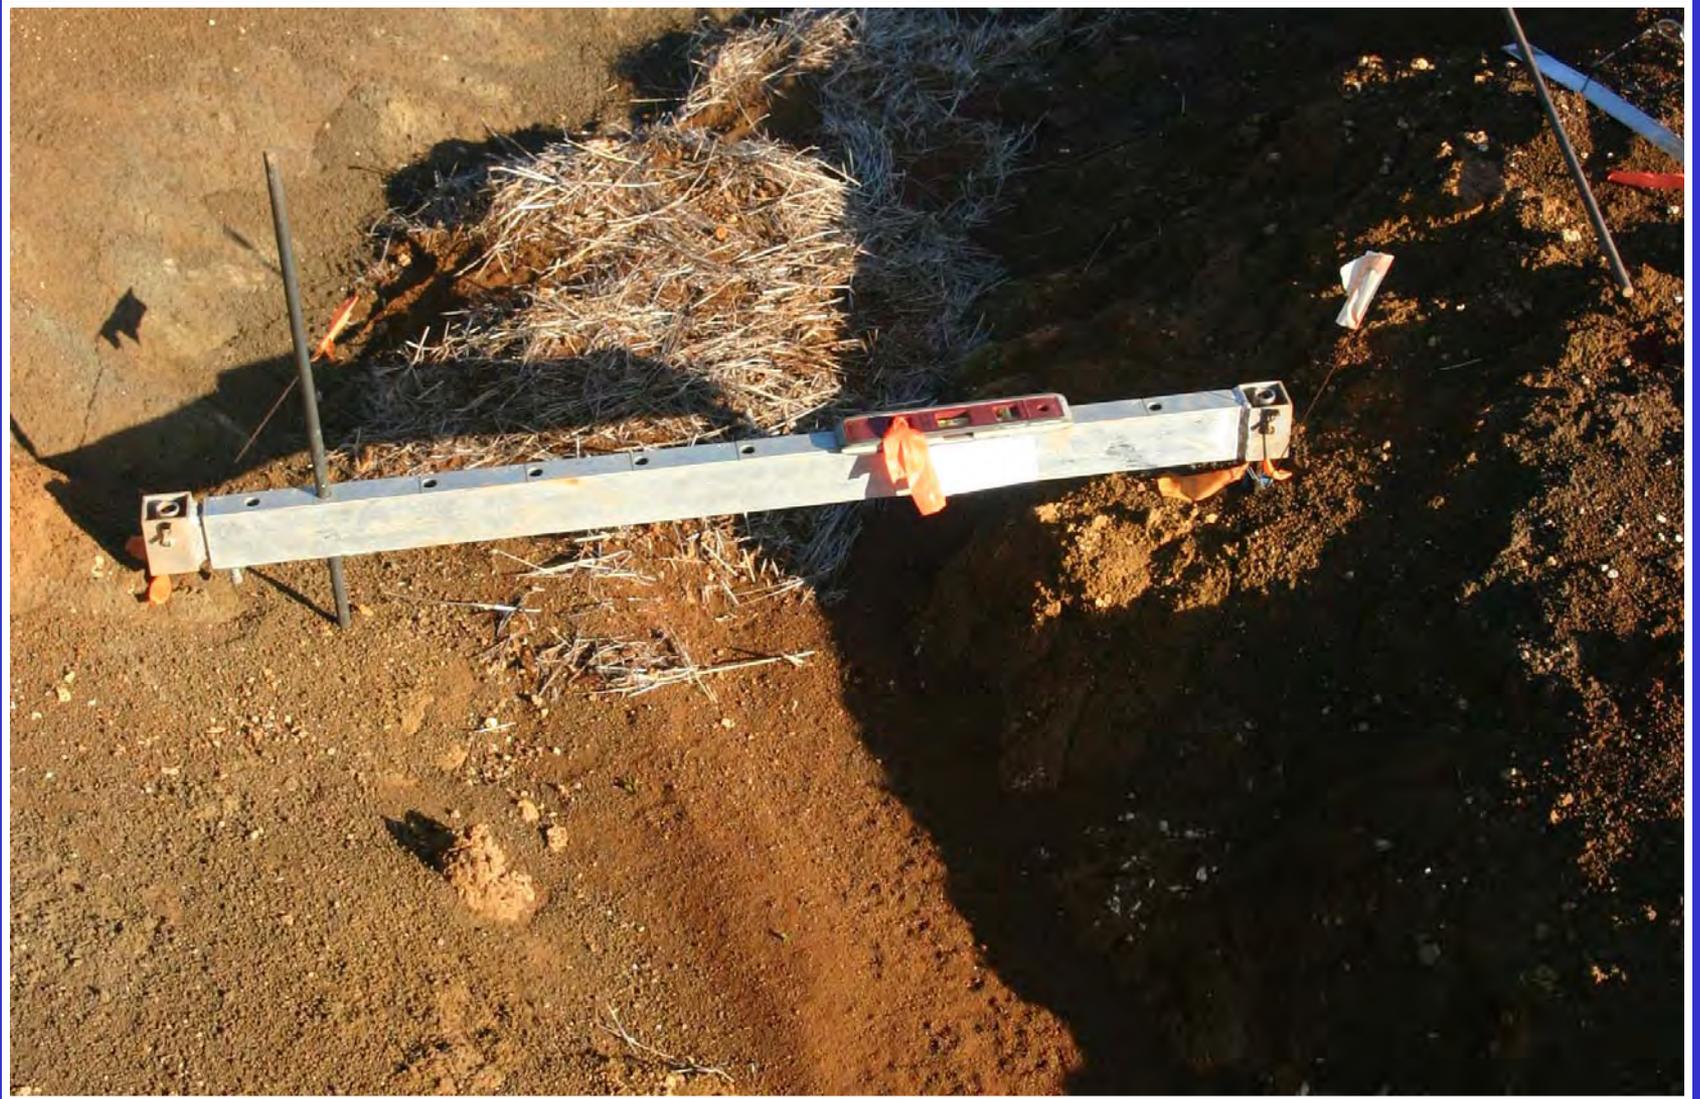
H35 – Deposition in rill caused by straw mulch

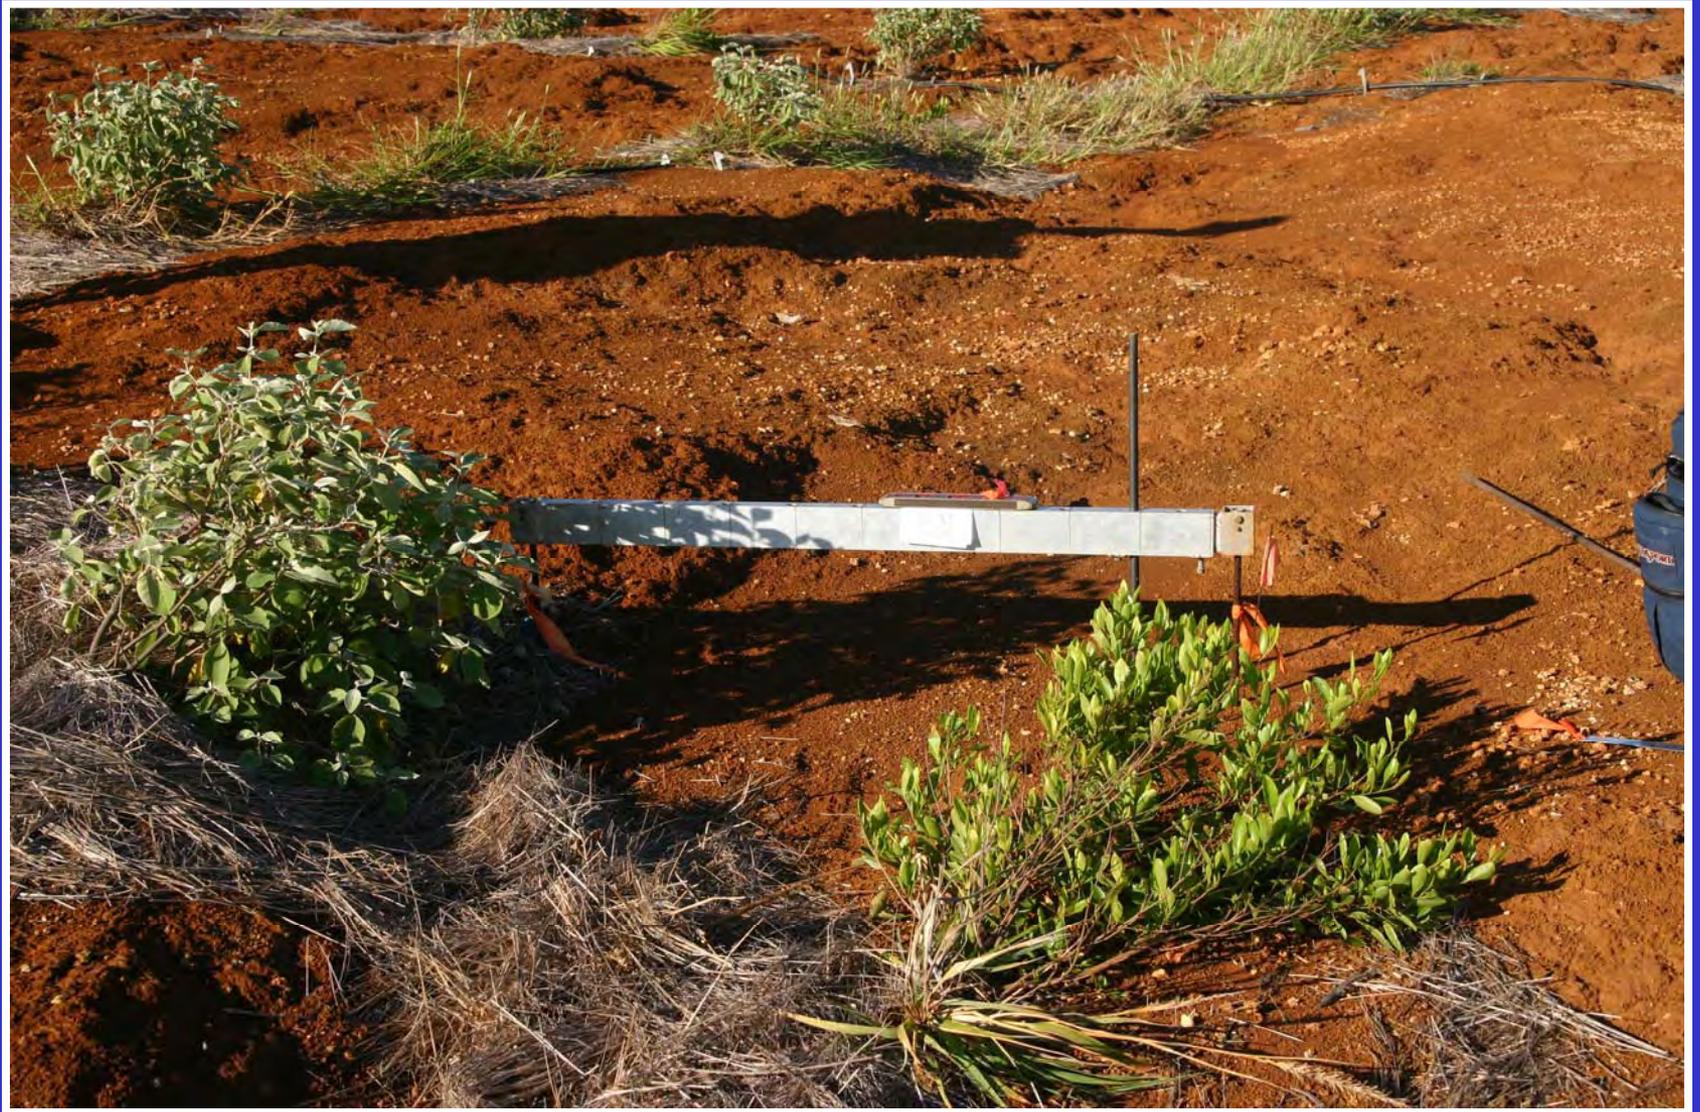
H37 – Deposition in rill caused by plants

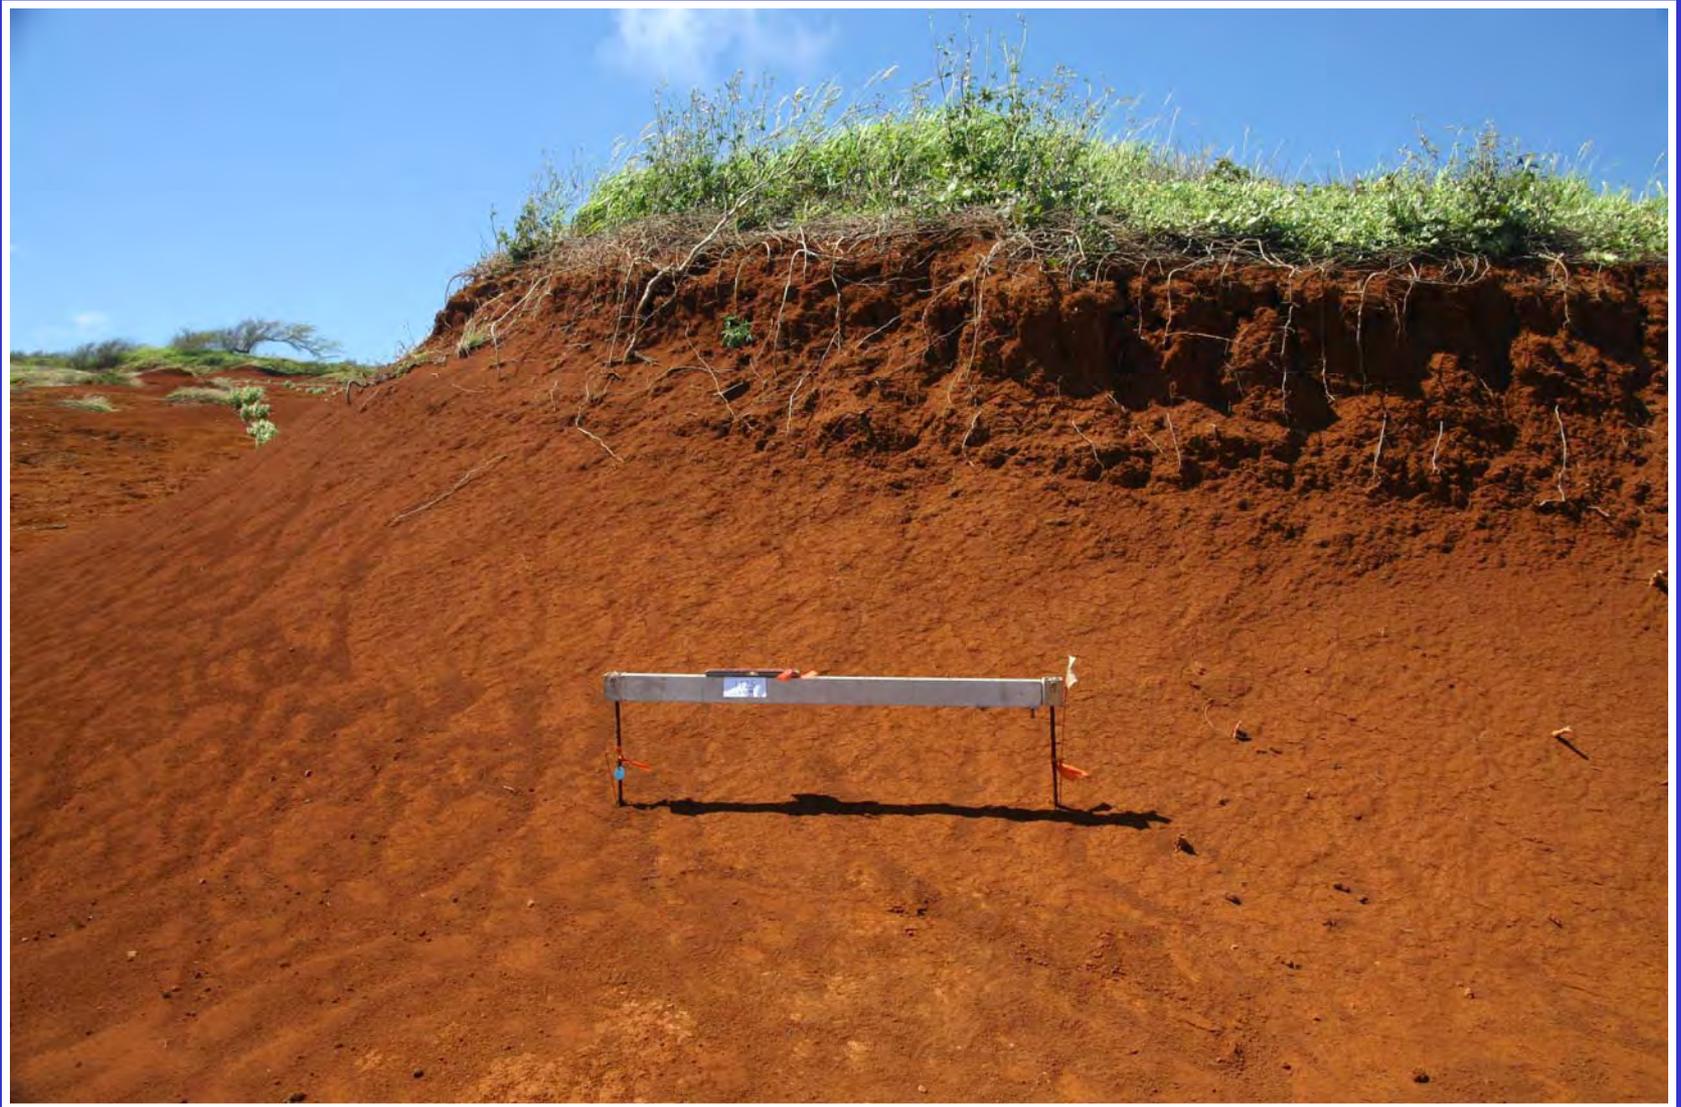
H25 – Erosion of hummock slope

Erosion rate high in hummocks
