MONITORING EROSION ON KAHO'OLAWA

A USGS study in cooperation with the Kaho'olawe Island Reserve Commission

By Scot Izuka, USGS

Presented at the Hawaii Water Quality
Conference March 25, 2008

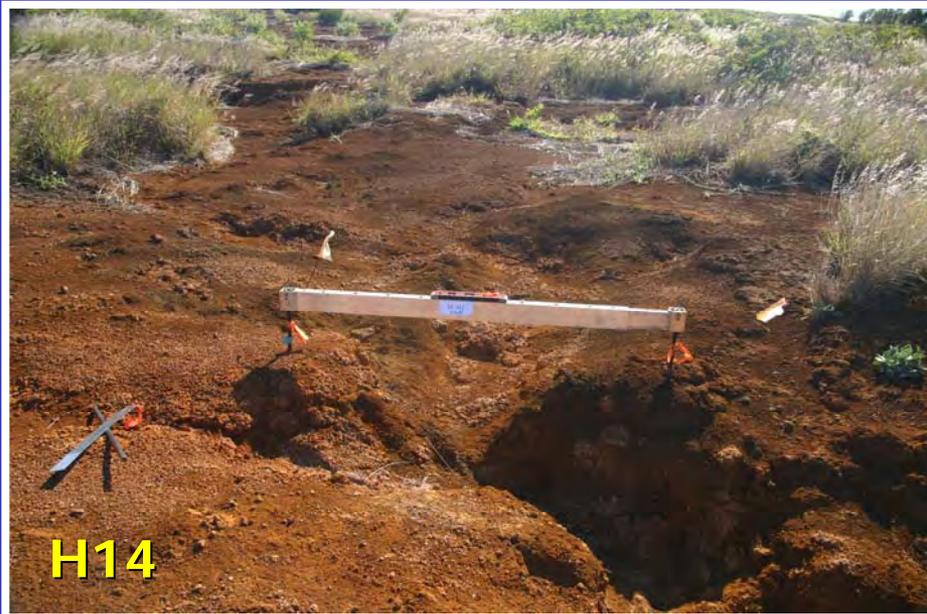
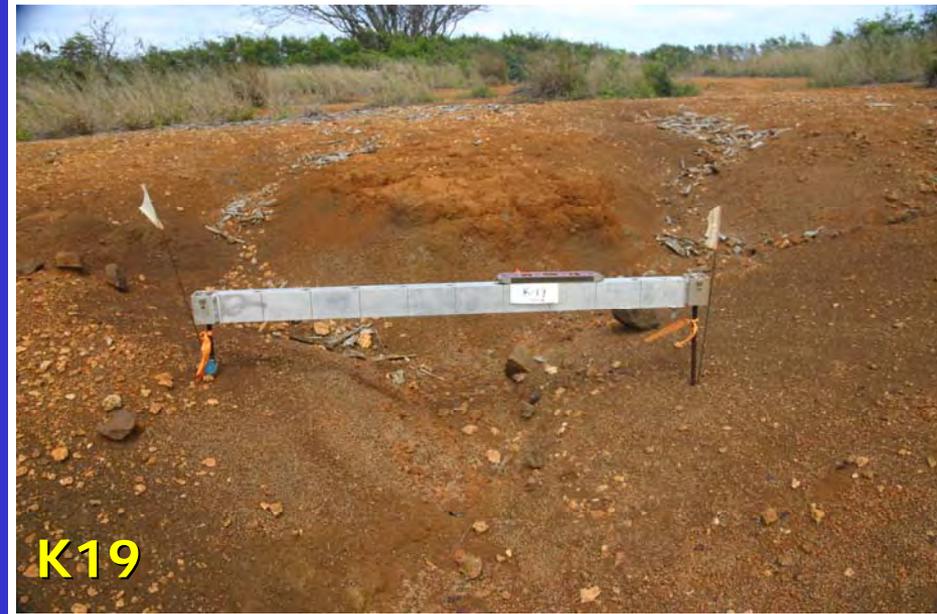
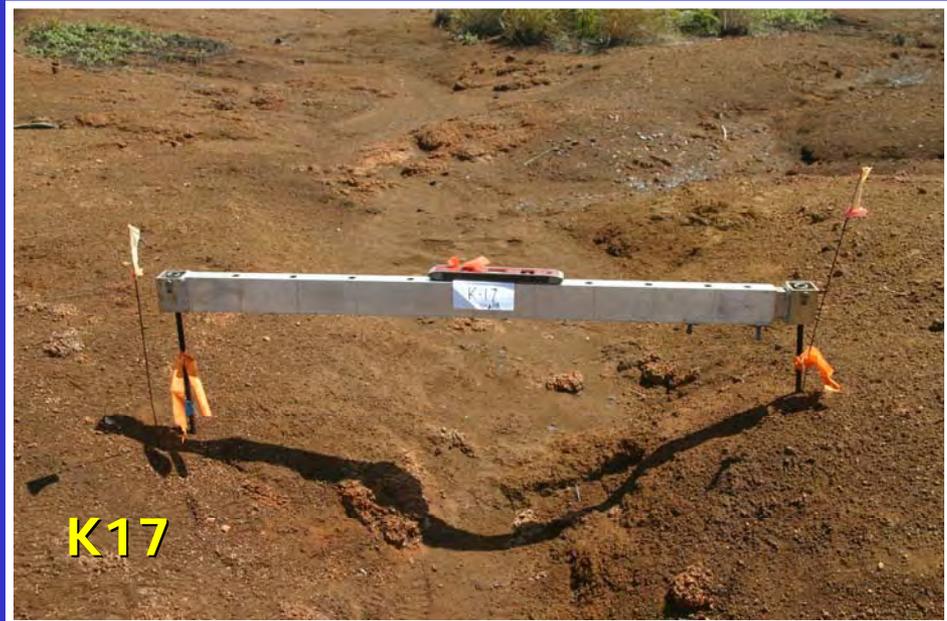
H14, K17, K19 – Rill erosion at non-restoration sites

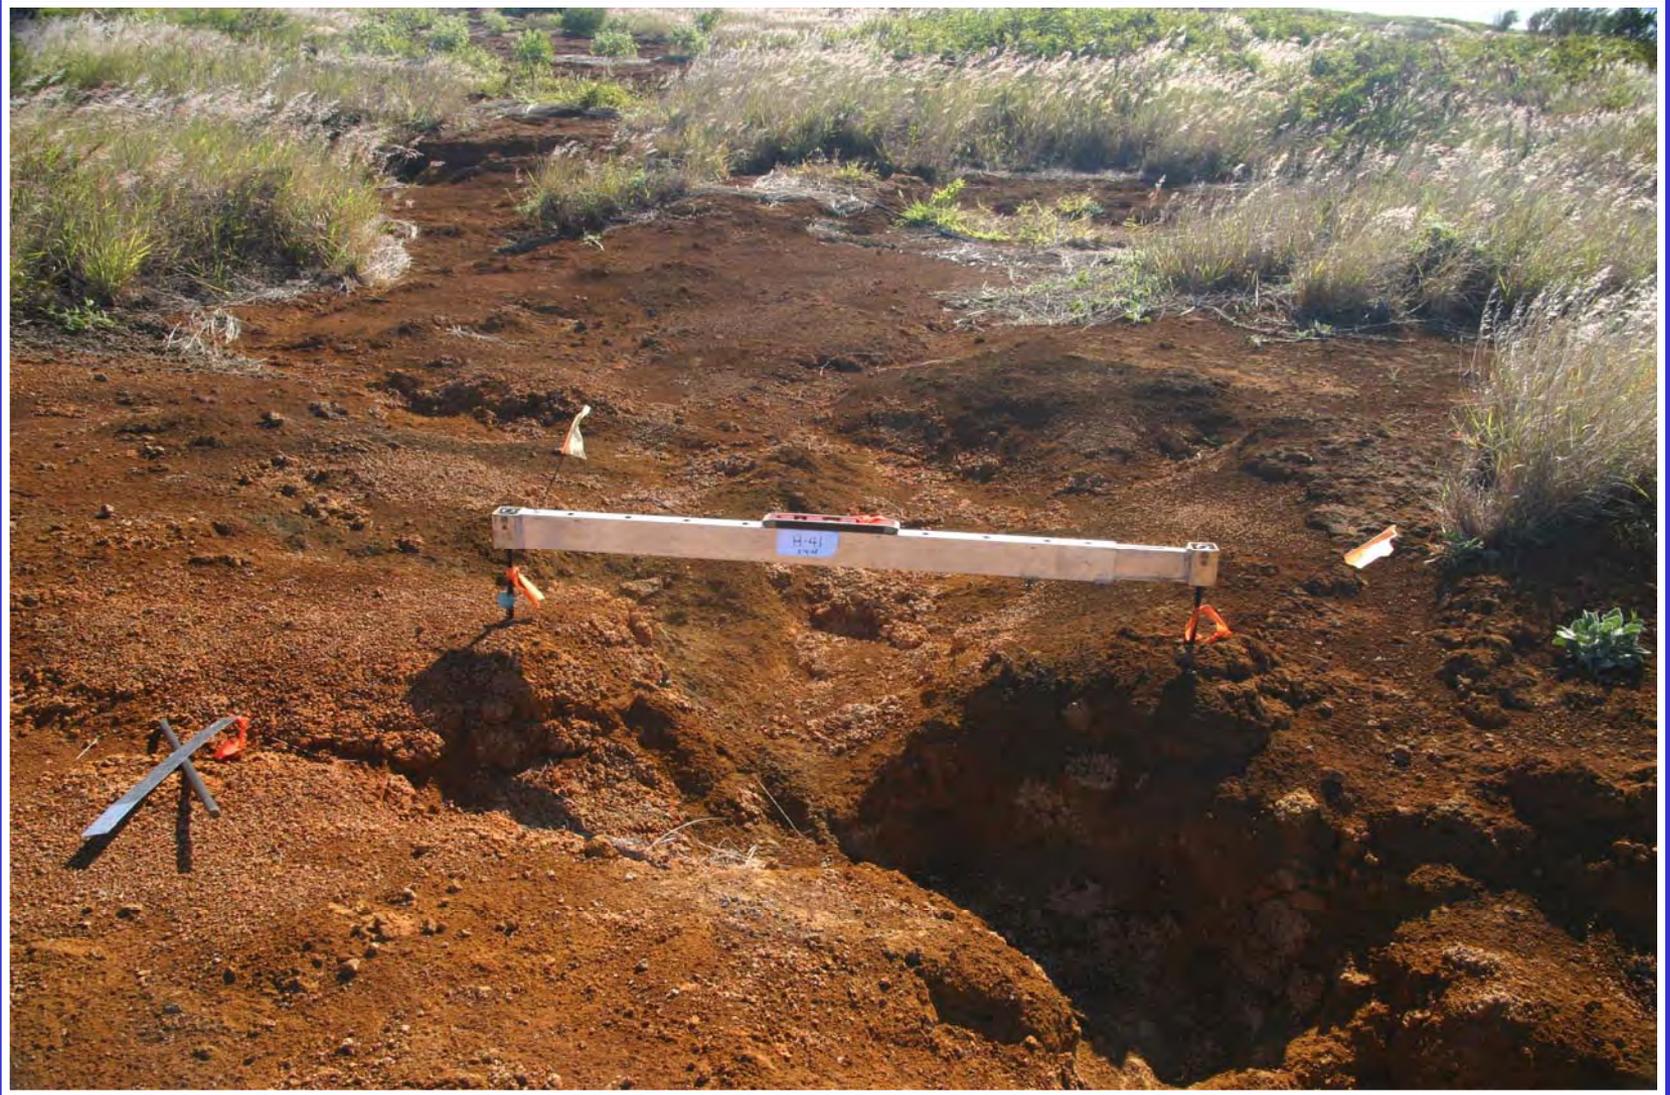
H41 – Rill erosion in restoration site

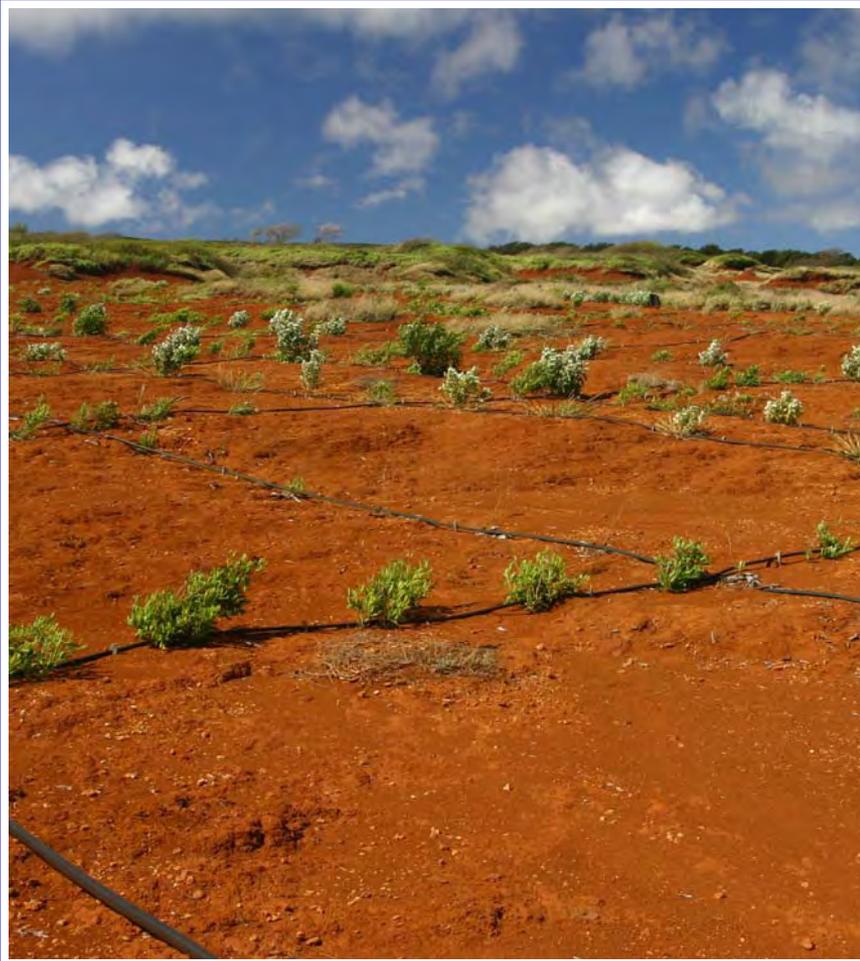
Restoration Effect Likely to Mature over Time

Plants are small at present

Erosion rate likely to change in the future as plants grow

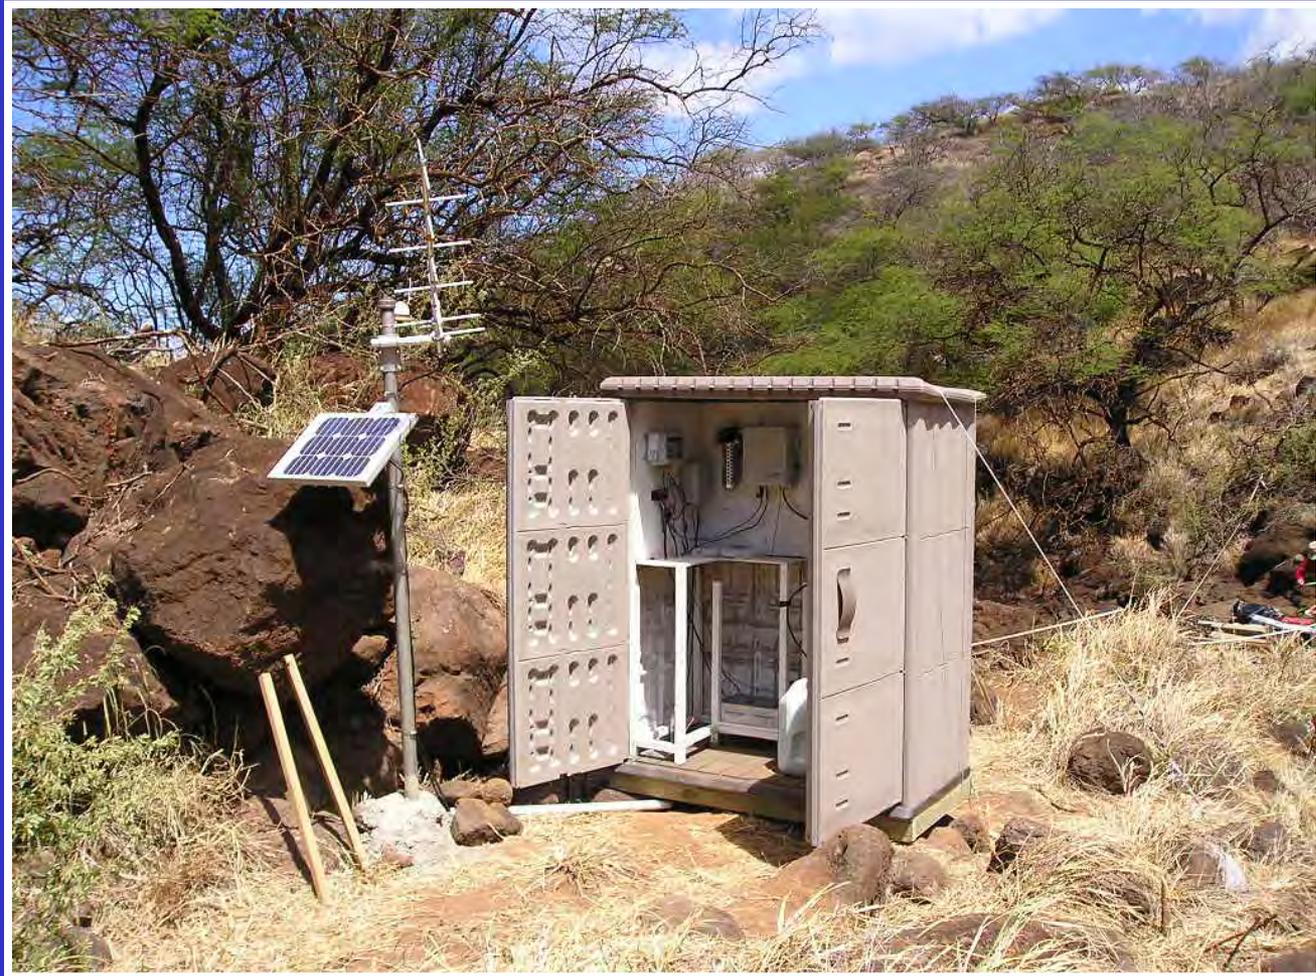
Stream Gage and Automatic Sediment Sampler Monitor Sediment Transport

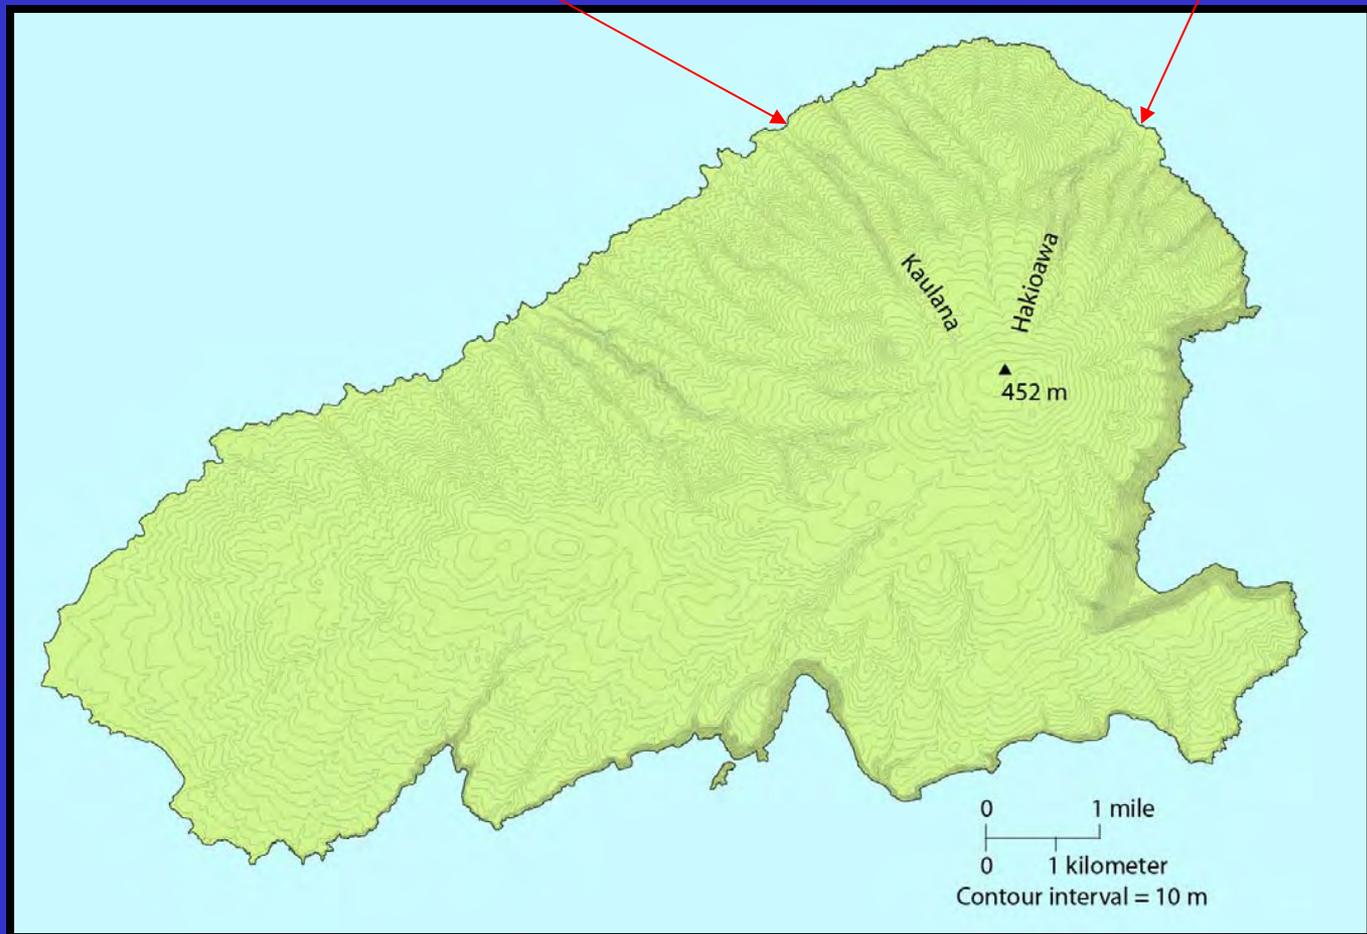
Sediment Discharge in Water Year 2007 (October 2006 through September 2007)

Kaulana:
400 tons

Hakioawa:
Data not yet available
